FINAL REPORT

MV. TBN 001

Off Hire Bunker & Condition Survey

"OFF HIRE BUNKER & CONDITION SURVEY"

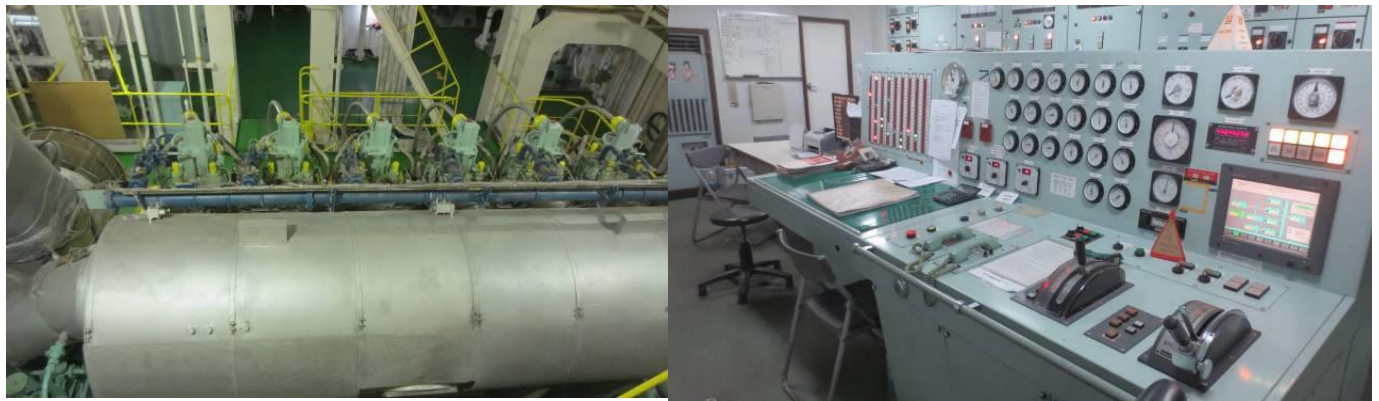
06. MACHINERY

Engine Room and Machinery overall outward condition is good, no significant damage observe during survey.

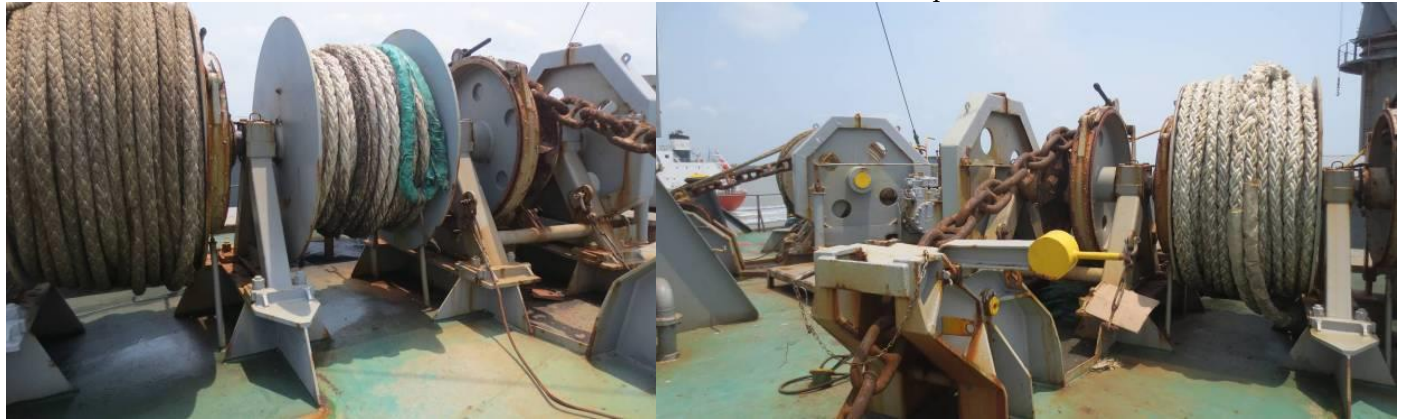
Fore Castle Deck

- Windlass, winches, bollards, mooring ropes/wires, fairleaders, anchors and anchors chains in apparent good order.
- Forecastle access hatch, bitts and windlass platforms no painted marked with different colors, winches without effective hazard markings. Thick Rust in Places.
- Mooring lines stored in direct contact to deck plating.

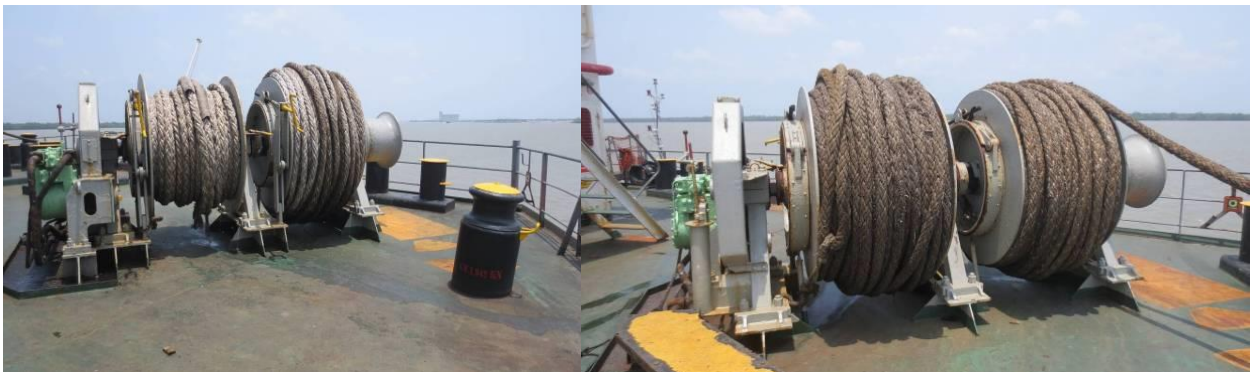
Poop Deck

- Windlass, winches, bollards, mooring ropes/wires, fairleaders, rust in places.
- Poop deck access hatch, bitts and windlass platforms not painted with different colors, unfortunately winches without effective hazard markings.
- Mooring lines stored in direct contact to deck plating.

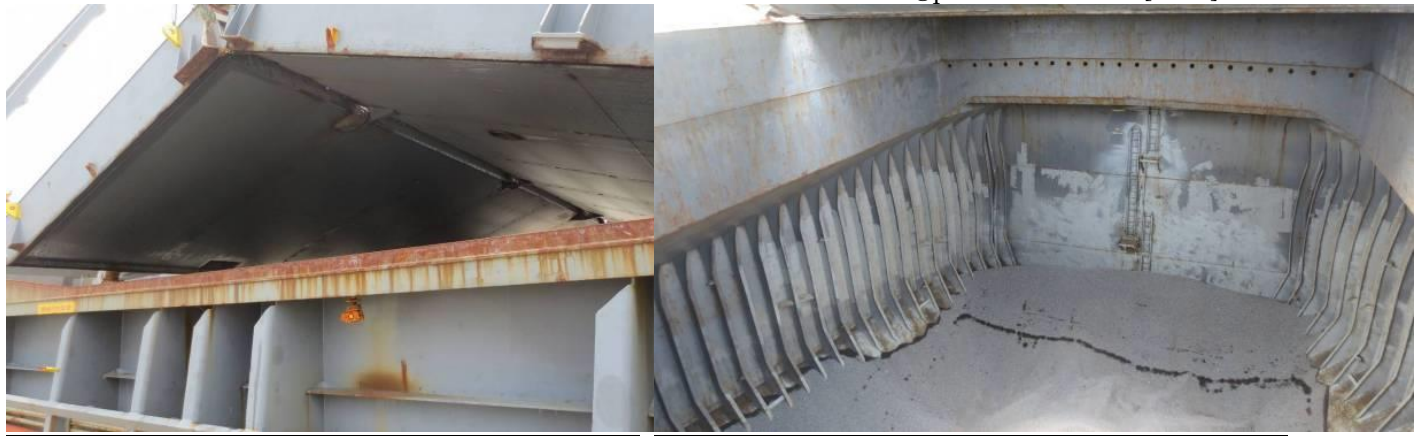
HOLD No. 01

For'd Flush Bulkhead plating: Well painted and maintained, presenting slight scratches.

Aft Corrugated Bulkhead/Stool Plating: Well painted and maintained, presenting slight scratches.

Aft Hold's Ladder: Slight indented on bottom section.

Pipes: No remarkable damage noticed.

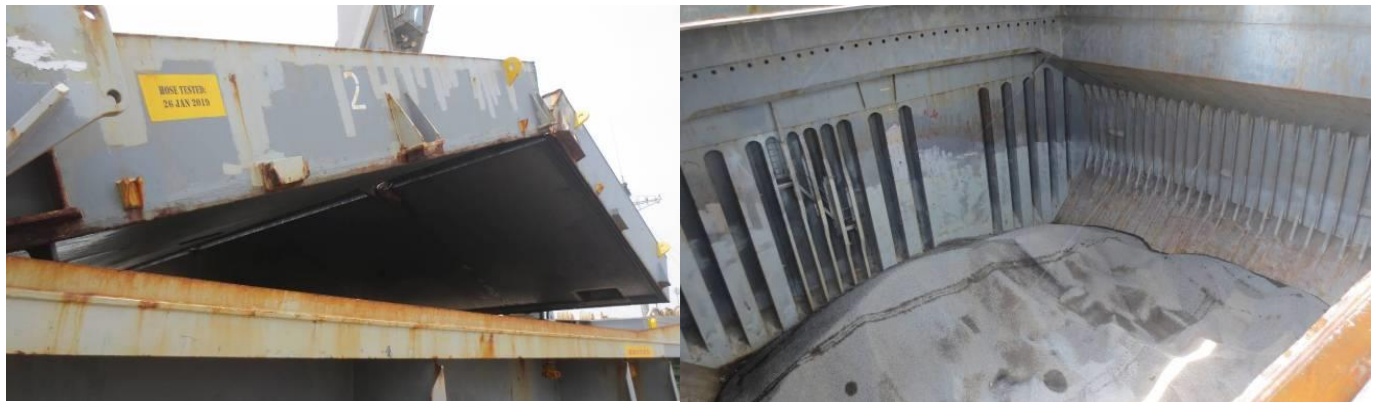
HOLD No. 02

For'd Corrugated Bulkhead/Stool: showing bed maintenance, plating rusted, presenting scratches and rust stains.

Aft Corrugated Bulkhead/Stool: showing bed maintenance, plating rusted, presenting scratches and rust stains.

Aft Hold's Ladder: Rusty indented on bottom section.

Pipes: No remarkable damage noticed but Rust in places.

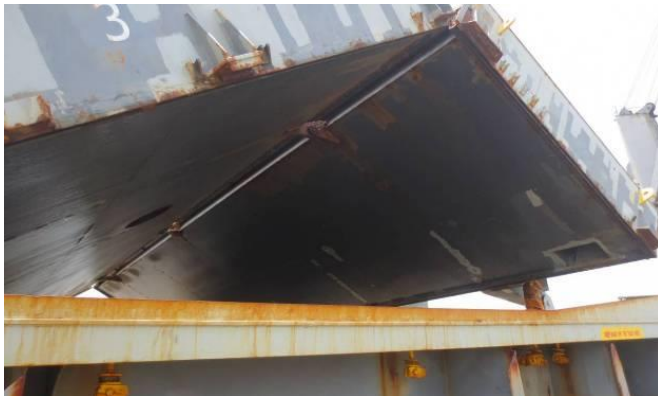
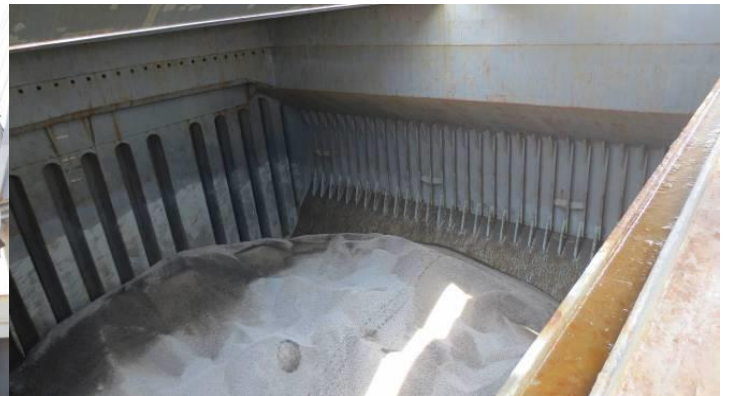
HOLD No. 03

For'd Corrugated Bulkhead/Stool: showing bed maintenance, plating rusted, presenting scratches and rust stains.

Aft Corrugated Bulkhead/Stool: showing bed maintenance, plating rusted, presenting scratches and rust stains.

Aft Hold's Ladder: Rusted indented on bottom section.

Pipes: No remarkable damage noticed but Rust in places.

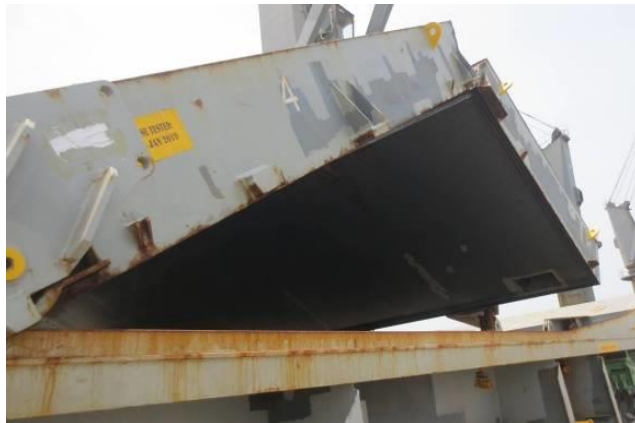
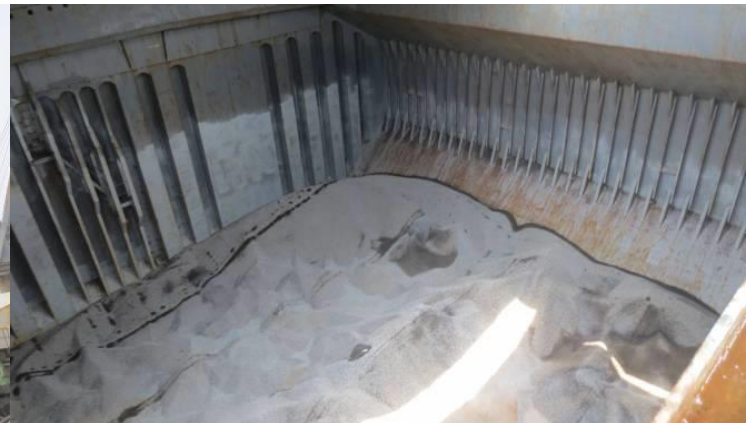
HOLD No. 04

For'd Corrugated Bulkhead/Stool: showing bed maintenance, plating rusted, presenting scratches and rust stains.

Aft Corrugated Bulkhead/Stool: showing bed maintenance, plating rusted, presenting scratches and rust stains.

Aft Hold's Ladder: Rusted indented on bottom section.

Pipes: No remarkable damage noticed but Rust in places.

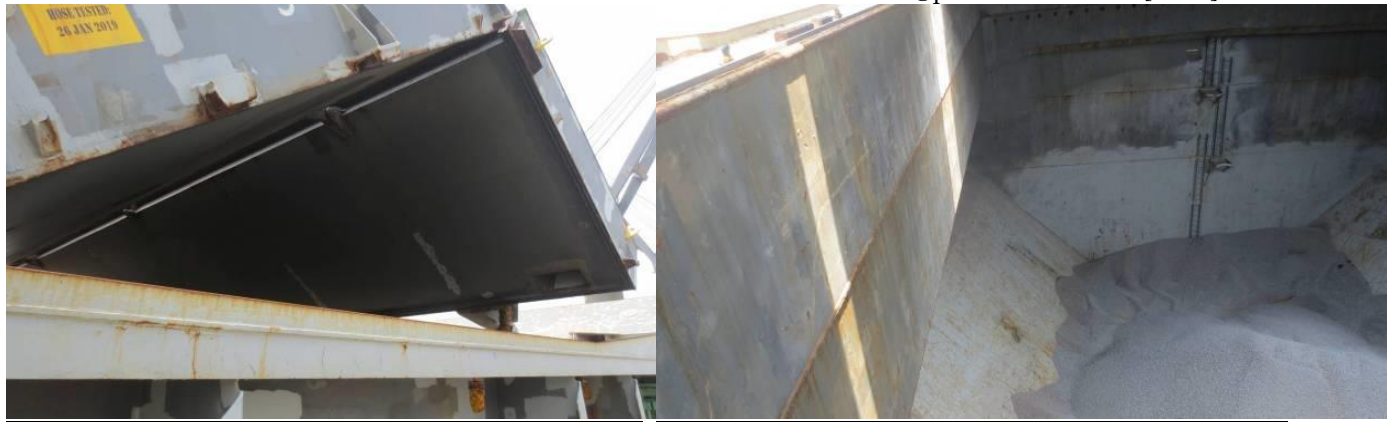
HOLD No. 05

For'd Corrugated Bulkhead/Stool: showing bed maintenance, plating rusted, presenting scratches and rust stains.

Aft Corrugated Bulkhead/Stool: showing bed maintenance, plating rusted, presenting scratches and rust stains.

Aft Hold's Ladder: Rusted indented on bottom section.

Pipes: No remarkable damage noticed but Rust in places.
